## DISPLAY SYSTEMS · BOEING 747 FFS

# Colour on, colour off: extending the life of a B747 CRT display

Non-destructive, component-level recovery of a legacy DU-7000 display unit through targeted inspection, cleaning and solder-joint restoration.

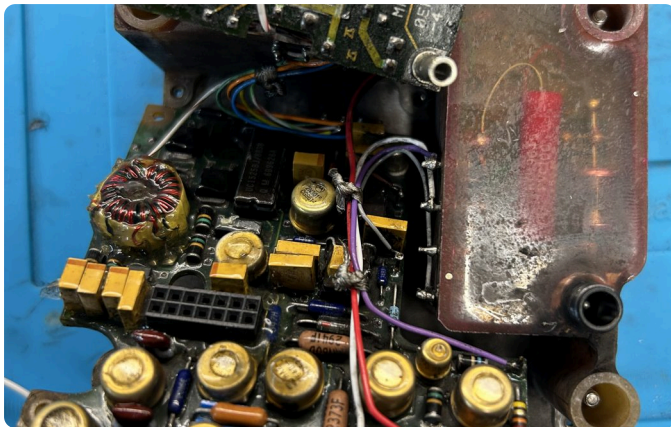
**BEFORE** Dust and fibrous debris on the internal assemblies as received.

Dust and fibres near the CRT power and interconnect areas can retain moisture and create leakage currents that worsen drift.

We fully disassembled the unit and inspected the high-voltage, power-regulation, video, I/O, processor, deflection and raster/stroke assemblies. Heavy contamination was removed, connectors serviced, capacitors screened and degraded solder joints reworked.

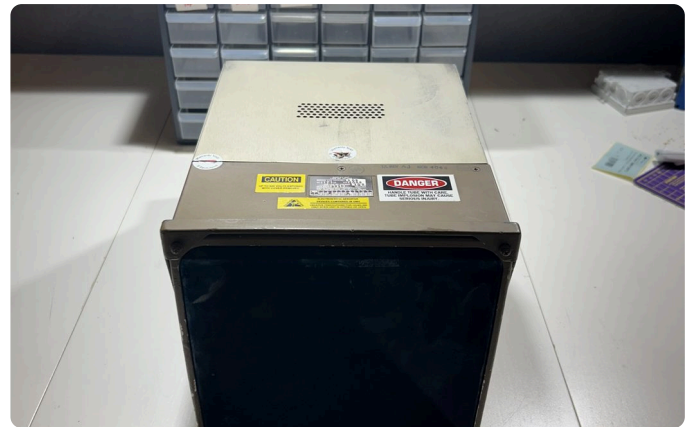
**AFTER** Reassembled DU-7000, returned for installation-level testing.

After reassembly and installation-level verification the display returned to operational service. Factory modifications and calibration were preserved, and no component was replaced without measured evidence.

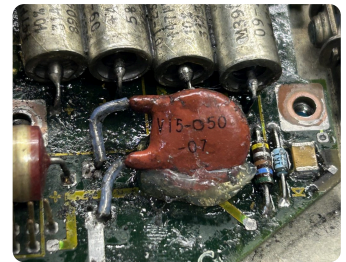
Joints worn by thermal cycling changed as the unit warmed, matching the progressive, intermittent fault.

Aged components under inspection.
